TEST REPORT # MI-19-11188-3A

On June 6th 2019, Micom Laboratories Inc. received a sample to perform Surface Finish Tests.

- Sample : PVC Siding

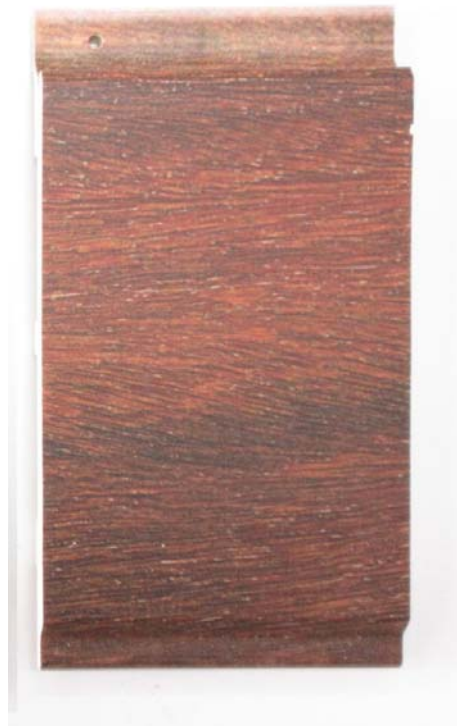
Sample – PVC Siding

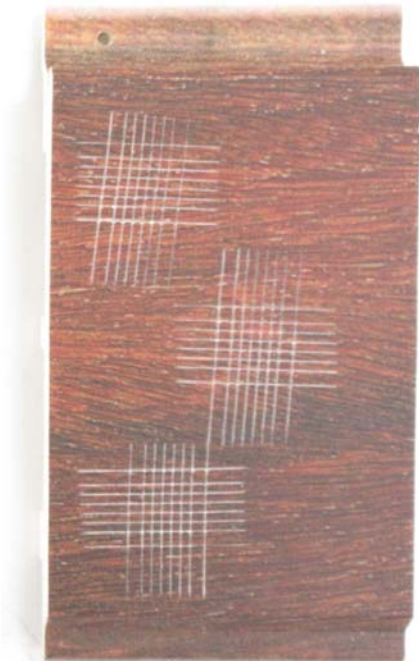
Sample		ASTM D3359
		<i>Adhesion Rating*1</i>
PVC Siding	#1	5B
	#2

Sample after adhesion test
