Rapport d'essai # MI-19-11188-3F

Le 6 juin 2019, les Laboratoires Micom Inc. ont reçu un (1) échantillon pour procéder à des essais de fini de surface.

- Échantillon : PVC Revêtement extérieur

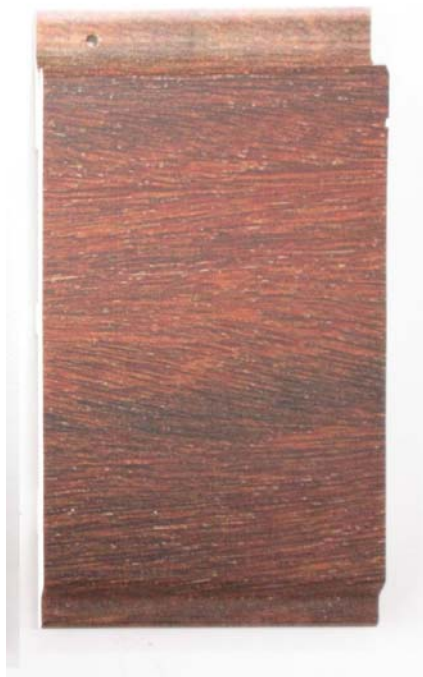
Échantillon PVC Revêtement extérieur

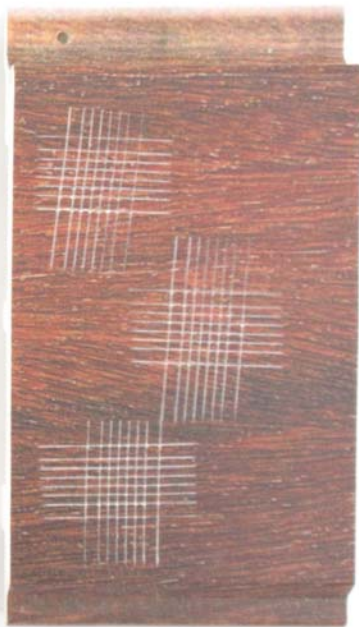
Échantillon après les essais d'adhésion

Échantillon		ASTM D3359
		<i>Adhesion Rating*1</i>
PVC Revêtement	#1	5B
	#2
