## Rapport d'essai # MI-19-11188-2F

Le 6 juin 2019, les Laboratoires Micom Inc. ont reçu un (1) échantillon pour procéder à des essais de fini de surface.

- Échantillon : PVC Decking

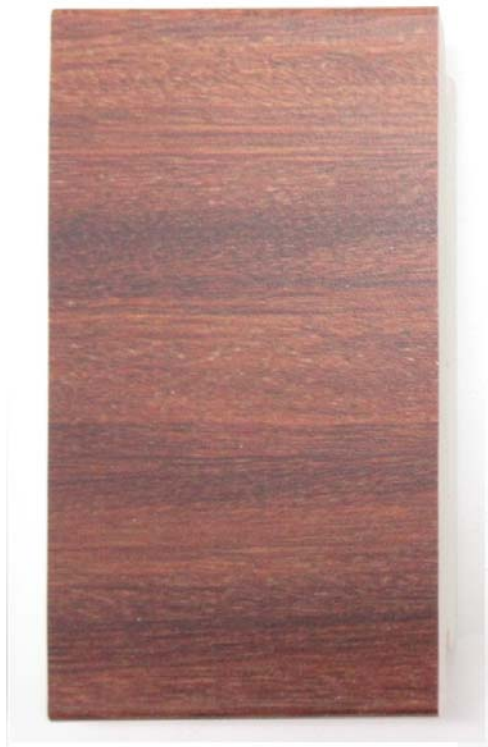
*Échantillon PVC Decking*

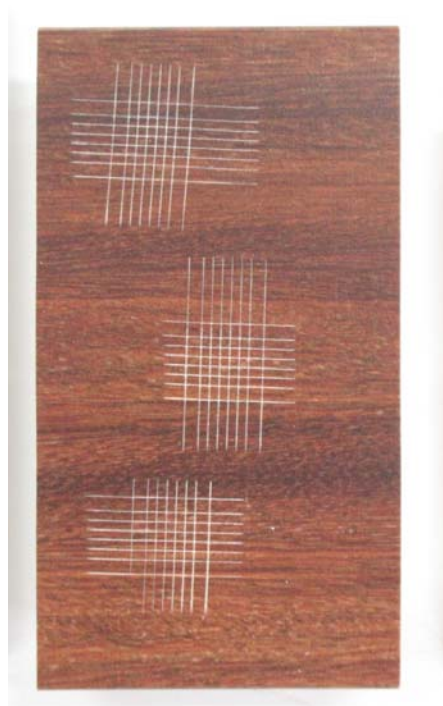
*Échantillon après les essais d'adhésion*

- ASTM D3359 (Measuring Adhesion by Tape Test)

Échantillon		ASTM D3359
		<i>Adhesion Rating*1</i>
PVC Decking	#1	5B
	#2
