TEST REPORT # MI-20-12184-3

On August 27th 2020, Micom Laboratories Inc. received 1 sample to perform Salt Spray Testing.

- Sample 3 : 1 x specimen, 3" x 6", Dizal_D-Alu_Salt-Spray-1

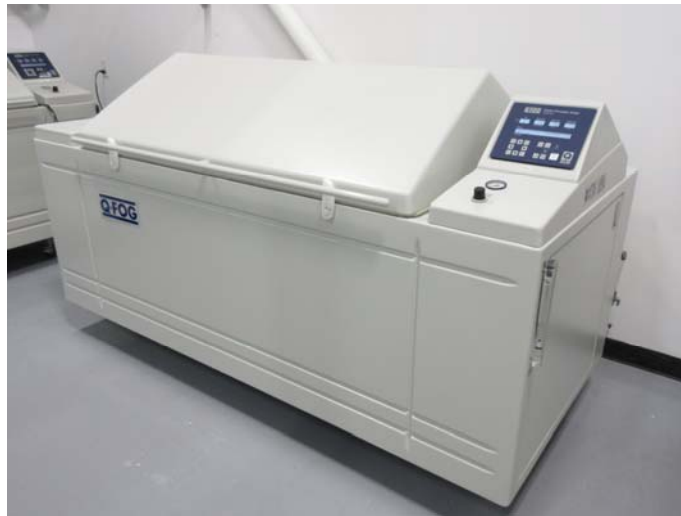
- pH range : 6.5 – 7.2
- Salt concentration : $5 \pm 1\%$
- Temperature : $35 \pm 2^\circ\text{C}$
- Collector : 1.0 – 2.0 mL/hour

Salt Fog/Spray machine used
