TEST REPORT # MI-20-12184-6

On August 27th 2020, Micom Laboratories Inc. received 1 sample to perform Salt Spray Testing.

- Sample 6 : 1 x specimen, 3" x 6", Dizal_ACM_Salt-Spray-1

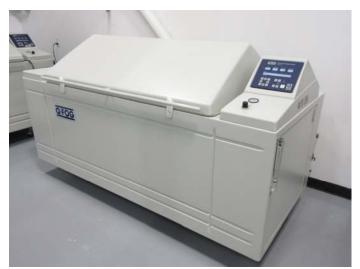
Sample was exposed as per ASTM B117 - Standard Practice for Operating Salt Spray (Fog) Apparatus. Conditions in the Salt Spray chamber:

Salt concentration: 5 ± 1%
 Temperature: 35 ± 2°C
 Collector: 1.0 – 2.0 mL/hour

Salt Fog/Spray machine used

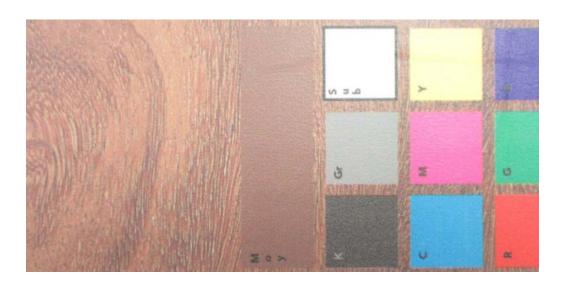
Sample 6 after 2000hrs exposure

No sign of corrosion was visible after the 2000 hours of exposition on the samples.
