# **TEST REPORT # MI-20-12184-2**

On August 27th 2020, Micom Laboratories Inc. received 1 sample to perform Salt Spray Testing.

- Sample 2 : 1 x specimen, 3" x 6", Dizal\_S-Cell\_Salt-Spray-1

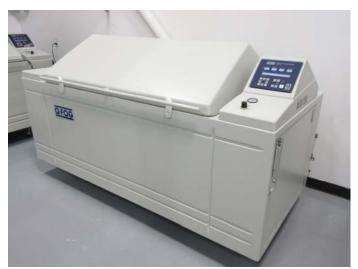
Sample was exposed as per ASTM B117 - Standard Practice for Operating Salt Spray (Fog) Apparatus. Conditions in the Salt Spray chamber:

Salt concentration: 5 ± 1%
Temperature: 35 ± 2°C
Collector: 1.0 – 2.0 mL/hour

Salt Fog/Spray machine used

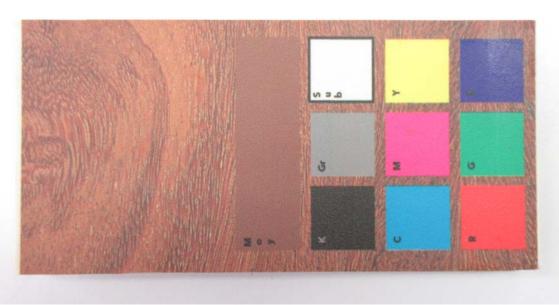
Sample 2 after 2000hrs exposure

No sign of corrosion was visible after the 2000 hours of exposition on the samples.
